NATIONAL ADVISORY COMMITTEE FOR AERONAUTICS

WARTIME REPORT

MEASUREMENTS IN FLIGHT OF THE STABILITY, LATERAL-
CONTROL, AND STALLING CHARACTERISTICS OF AN AIRPLANE
EQUIPPED WITH FULL-SPAN ZAP FLAPS AND
SPOILER-TYPE AILERONS

MEMORANDUM REPORT

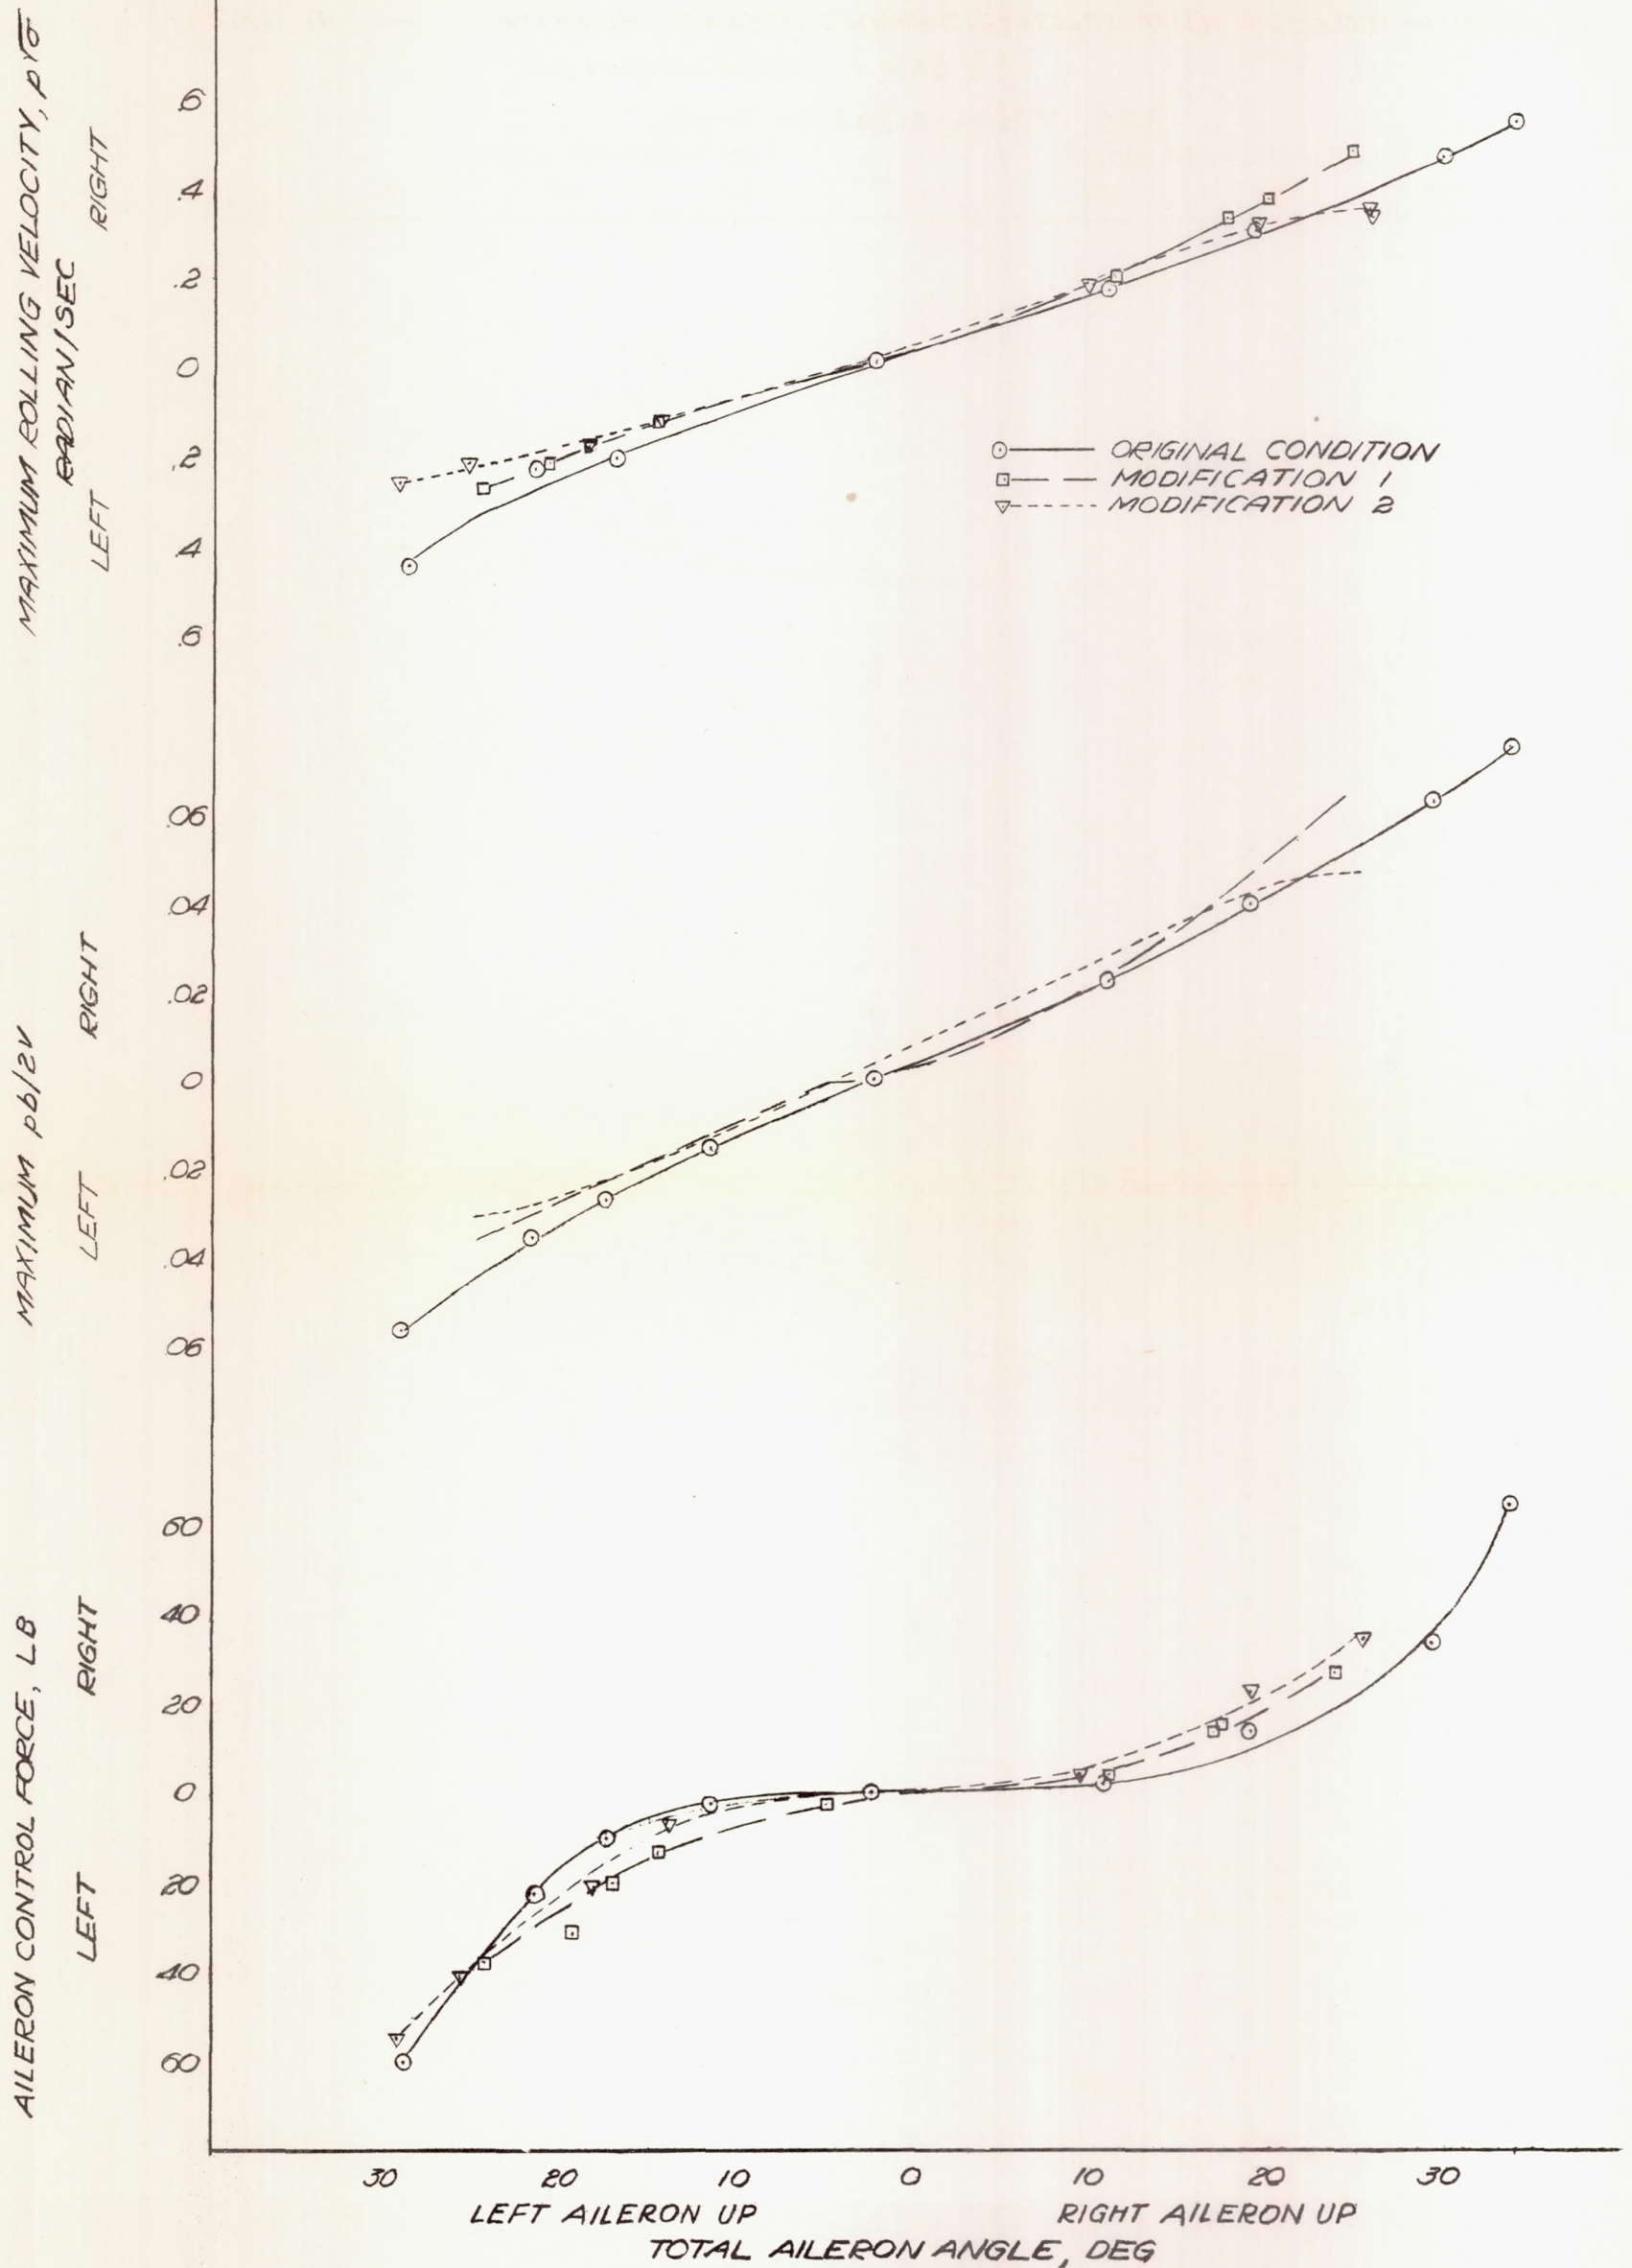
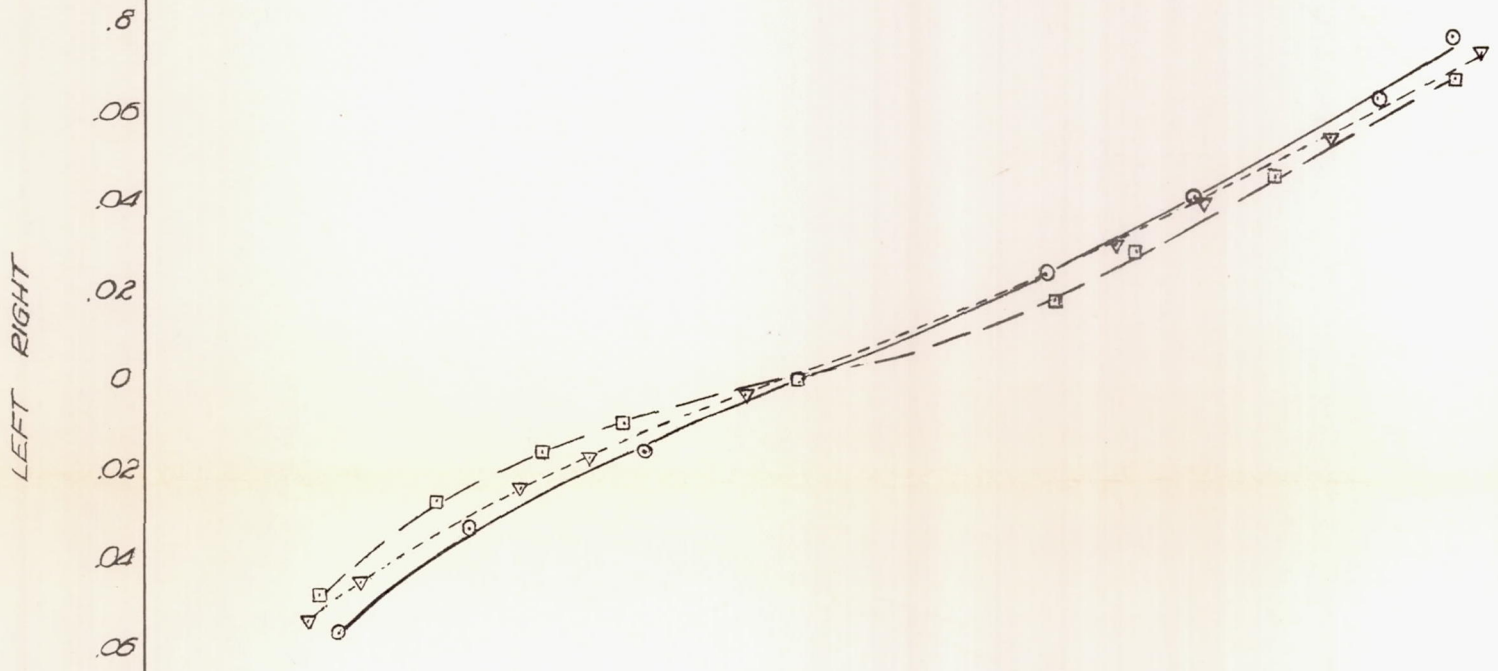
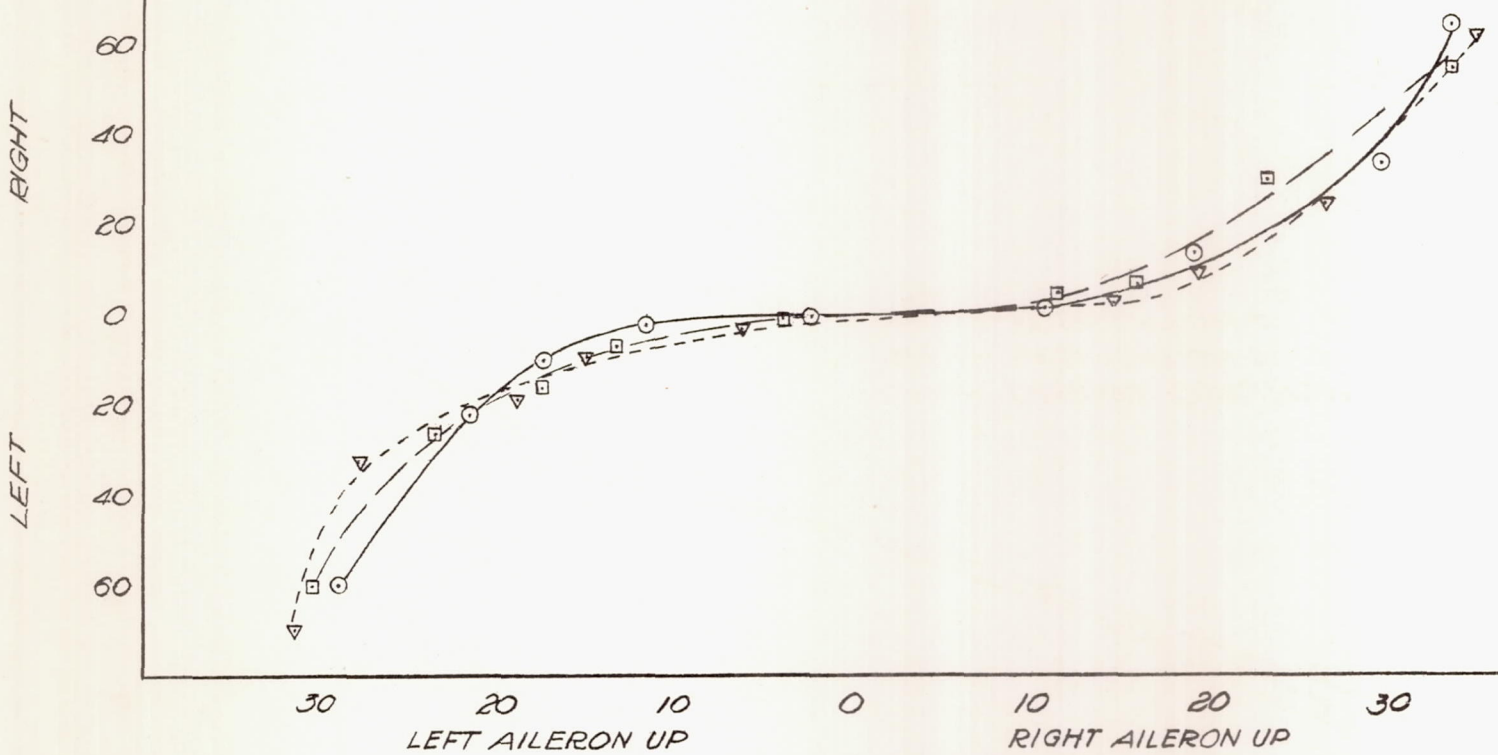
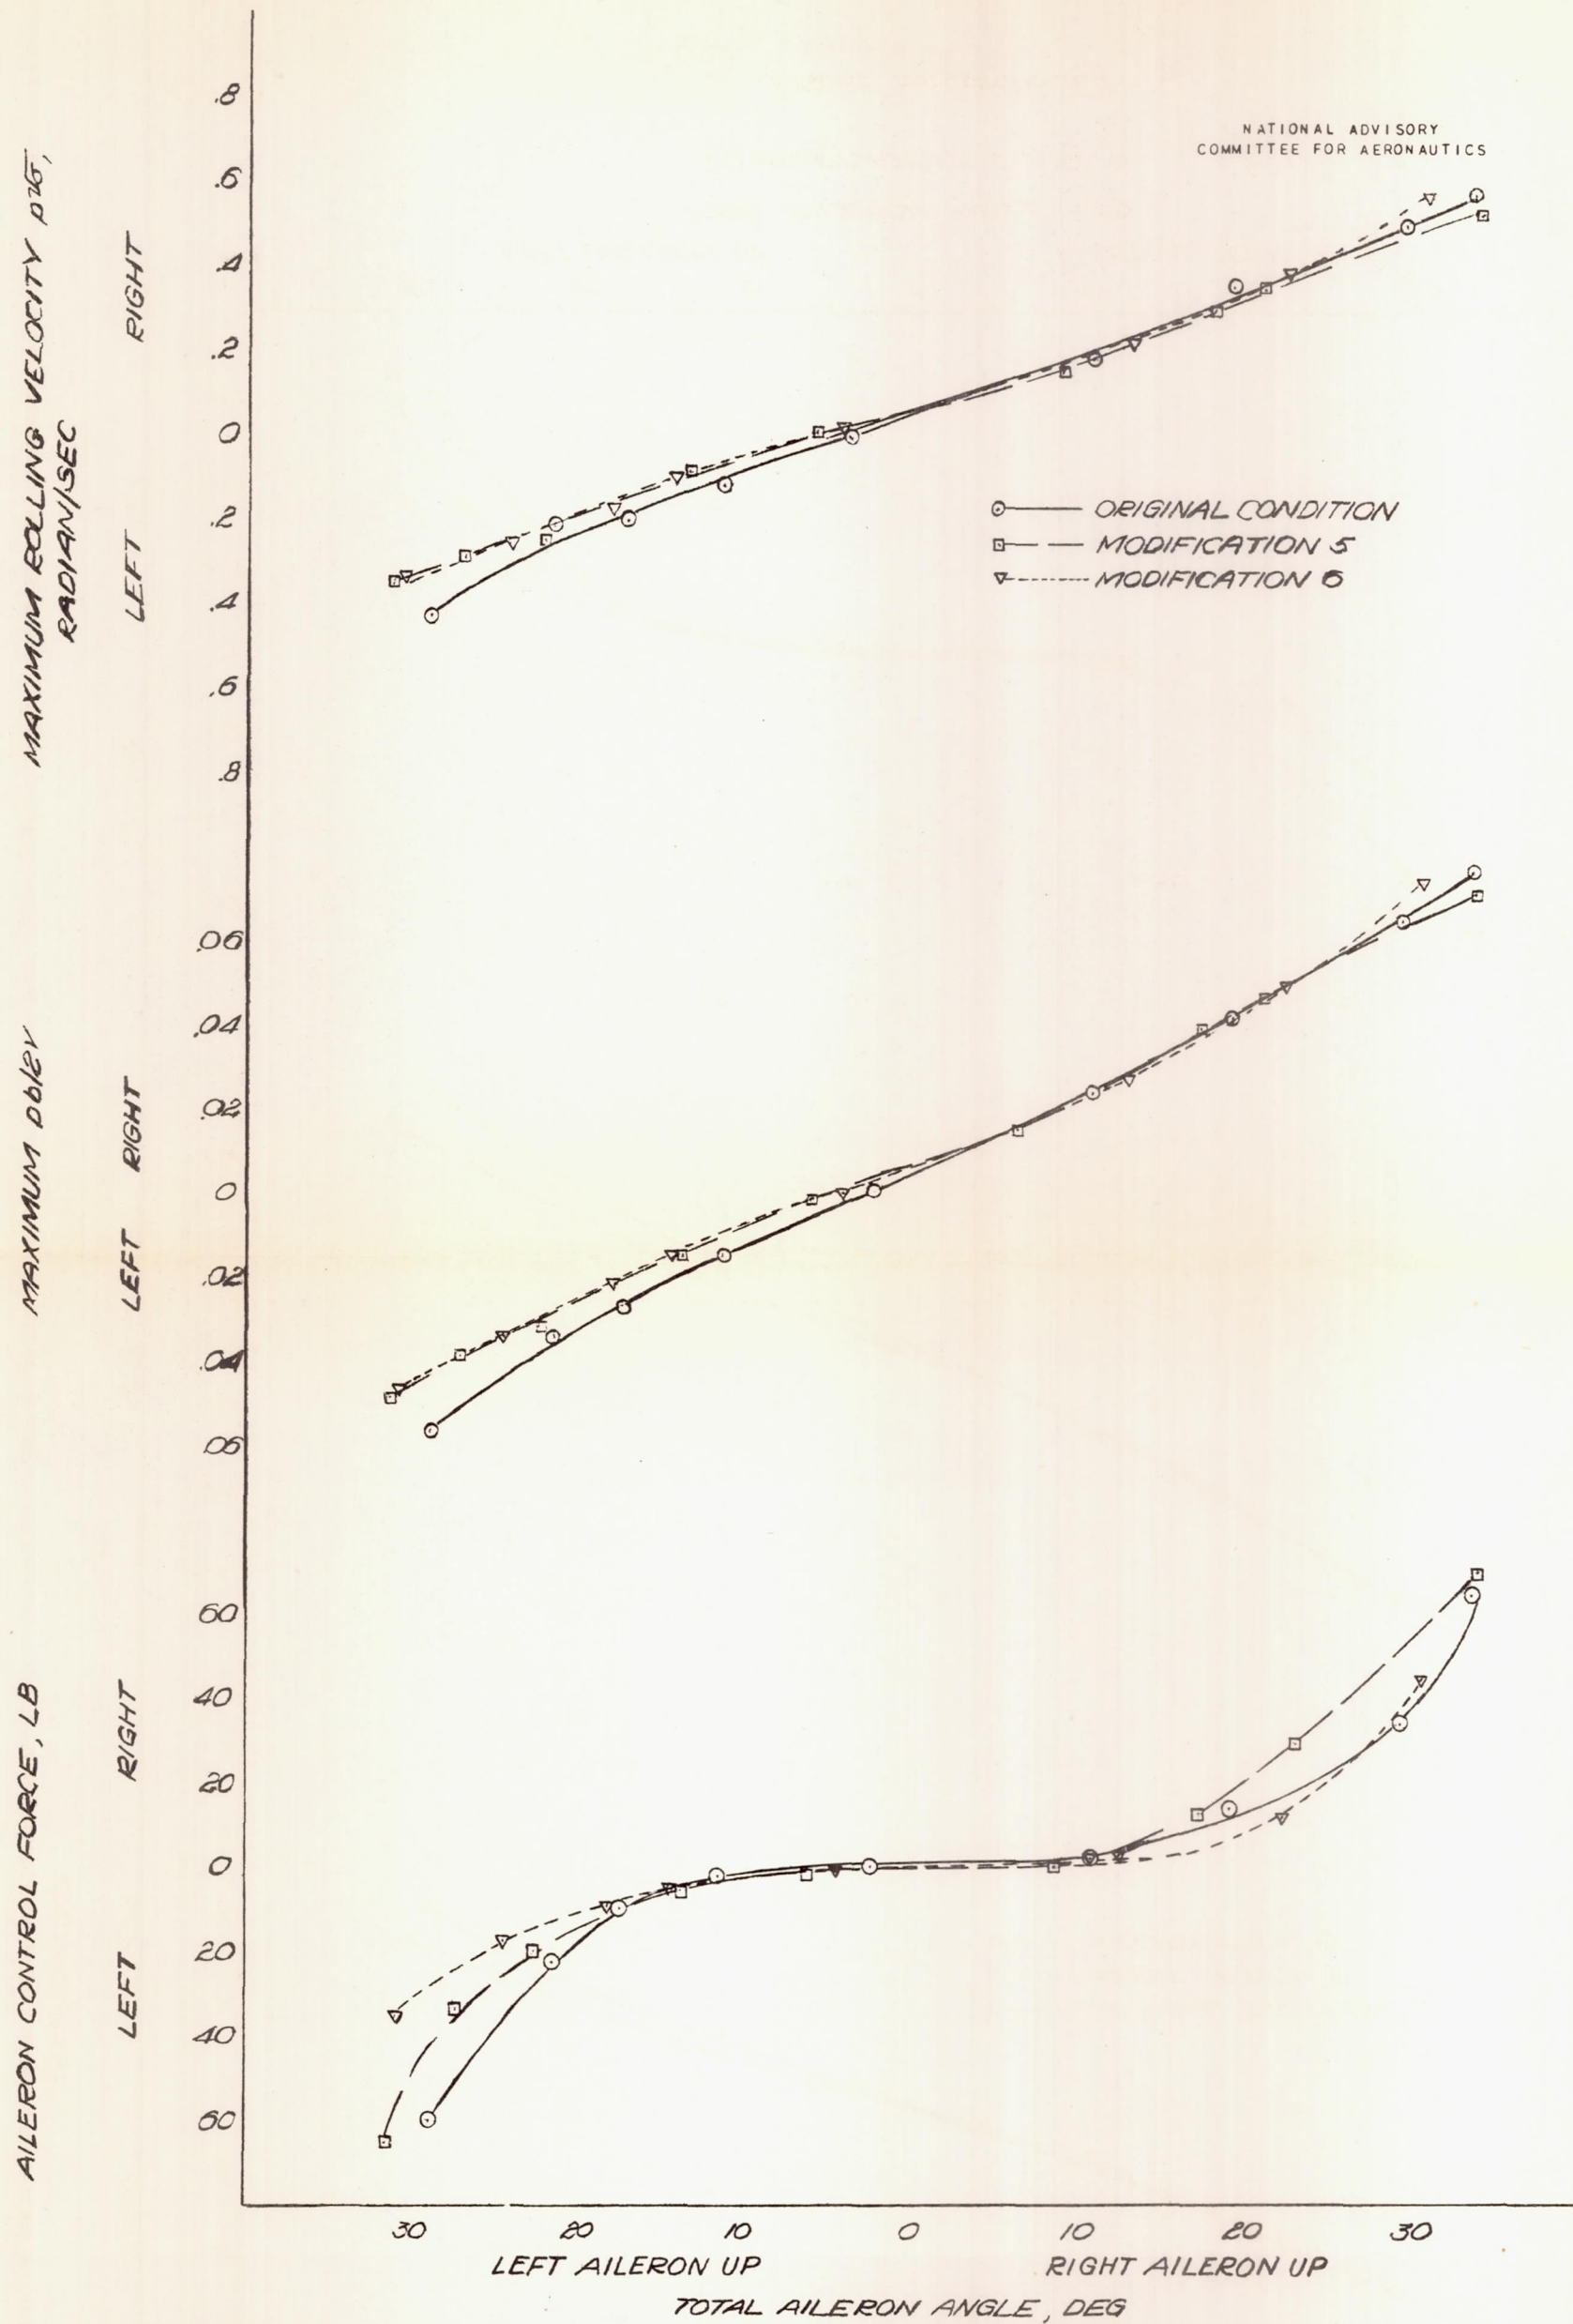
FIGURE 36. — AILERON CONTROL CHARACTERISTICS WITH MODIFIED AILERONS, RATED POWER, FLAPS UP, 92 MILES PER HOUR.

FIGURE 36-CONTINUED

The aileron control characteristics of the airplane with the several modifications of the aileron surfaces are indicated by the curves of figures 36 to 38. Corresponding curves for the original condition have been included for purposes of comparison. The maximum values of $pb/2V$ resulting from a lateral-control force of 30 pounds are tabulated below for rated-power flight for each aileron modification.

Modification 1.— The effectiveness of the vanes in changing the lateral-control-force characteristics is indicated by a comparison of the results of the aileron rolls made with the vanes in the nose-down position with the corresponding results for the original nose-up vane condition (figs. 36(a), 37(a), and 38(a)). It is seen that, as a result of this vane adjustment, the control forces were increased without any appreciable increase in the corresponding rolling velocities. This is to be expected as the vanes in their nose-up position act as lifting surfaces tending to produce aerodynamic balance and consequent reduction in the aileron hinge moments. From the above table it may be observed that the resulting rolling criterion was reduced by this modification. However, the general shapes of the several curves remained unchanged.

Modification 6.— In order to decrease the control forces further, the upper surface of the remaining panel was reduced in area. From a comparison of the curves pertaining to this modification with those of modification 5 (figs. 36(c), 37(c), and 38(c)), it may be observed that the control forces were reduced from those of the previous modification with no accompanying decrease in rolling velocities. From the above table it is noted that the rolling criterion is, in general, higher for this modification than for any of the preceding changes and in a few flight conditions nearly satisfies the requirement of 0.07 recommended in references 3 and 4.
